Riverfront Remediation:  
Redevelopment for Human Access and Wildlife Health

MASTER OF LANDSCAPE ARCHITECTURE

A master plan proposal for the former ARMCO Steel manufacturing site in Kansas City, Missouri to control and remove pollutants contributing to ground and water contamination.

ARMCO SITE, Kansas City, MO

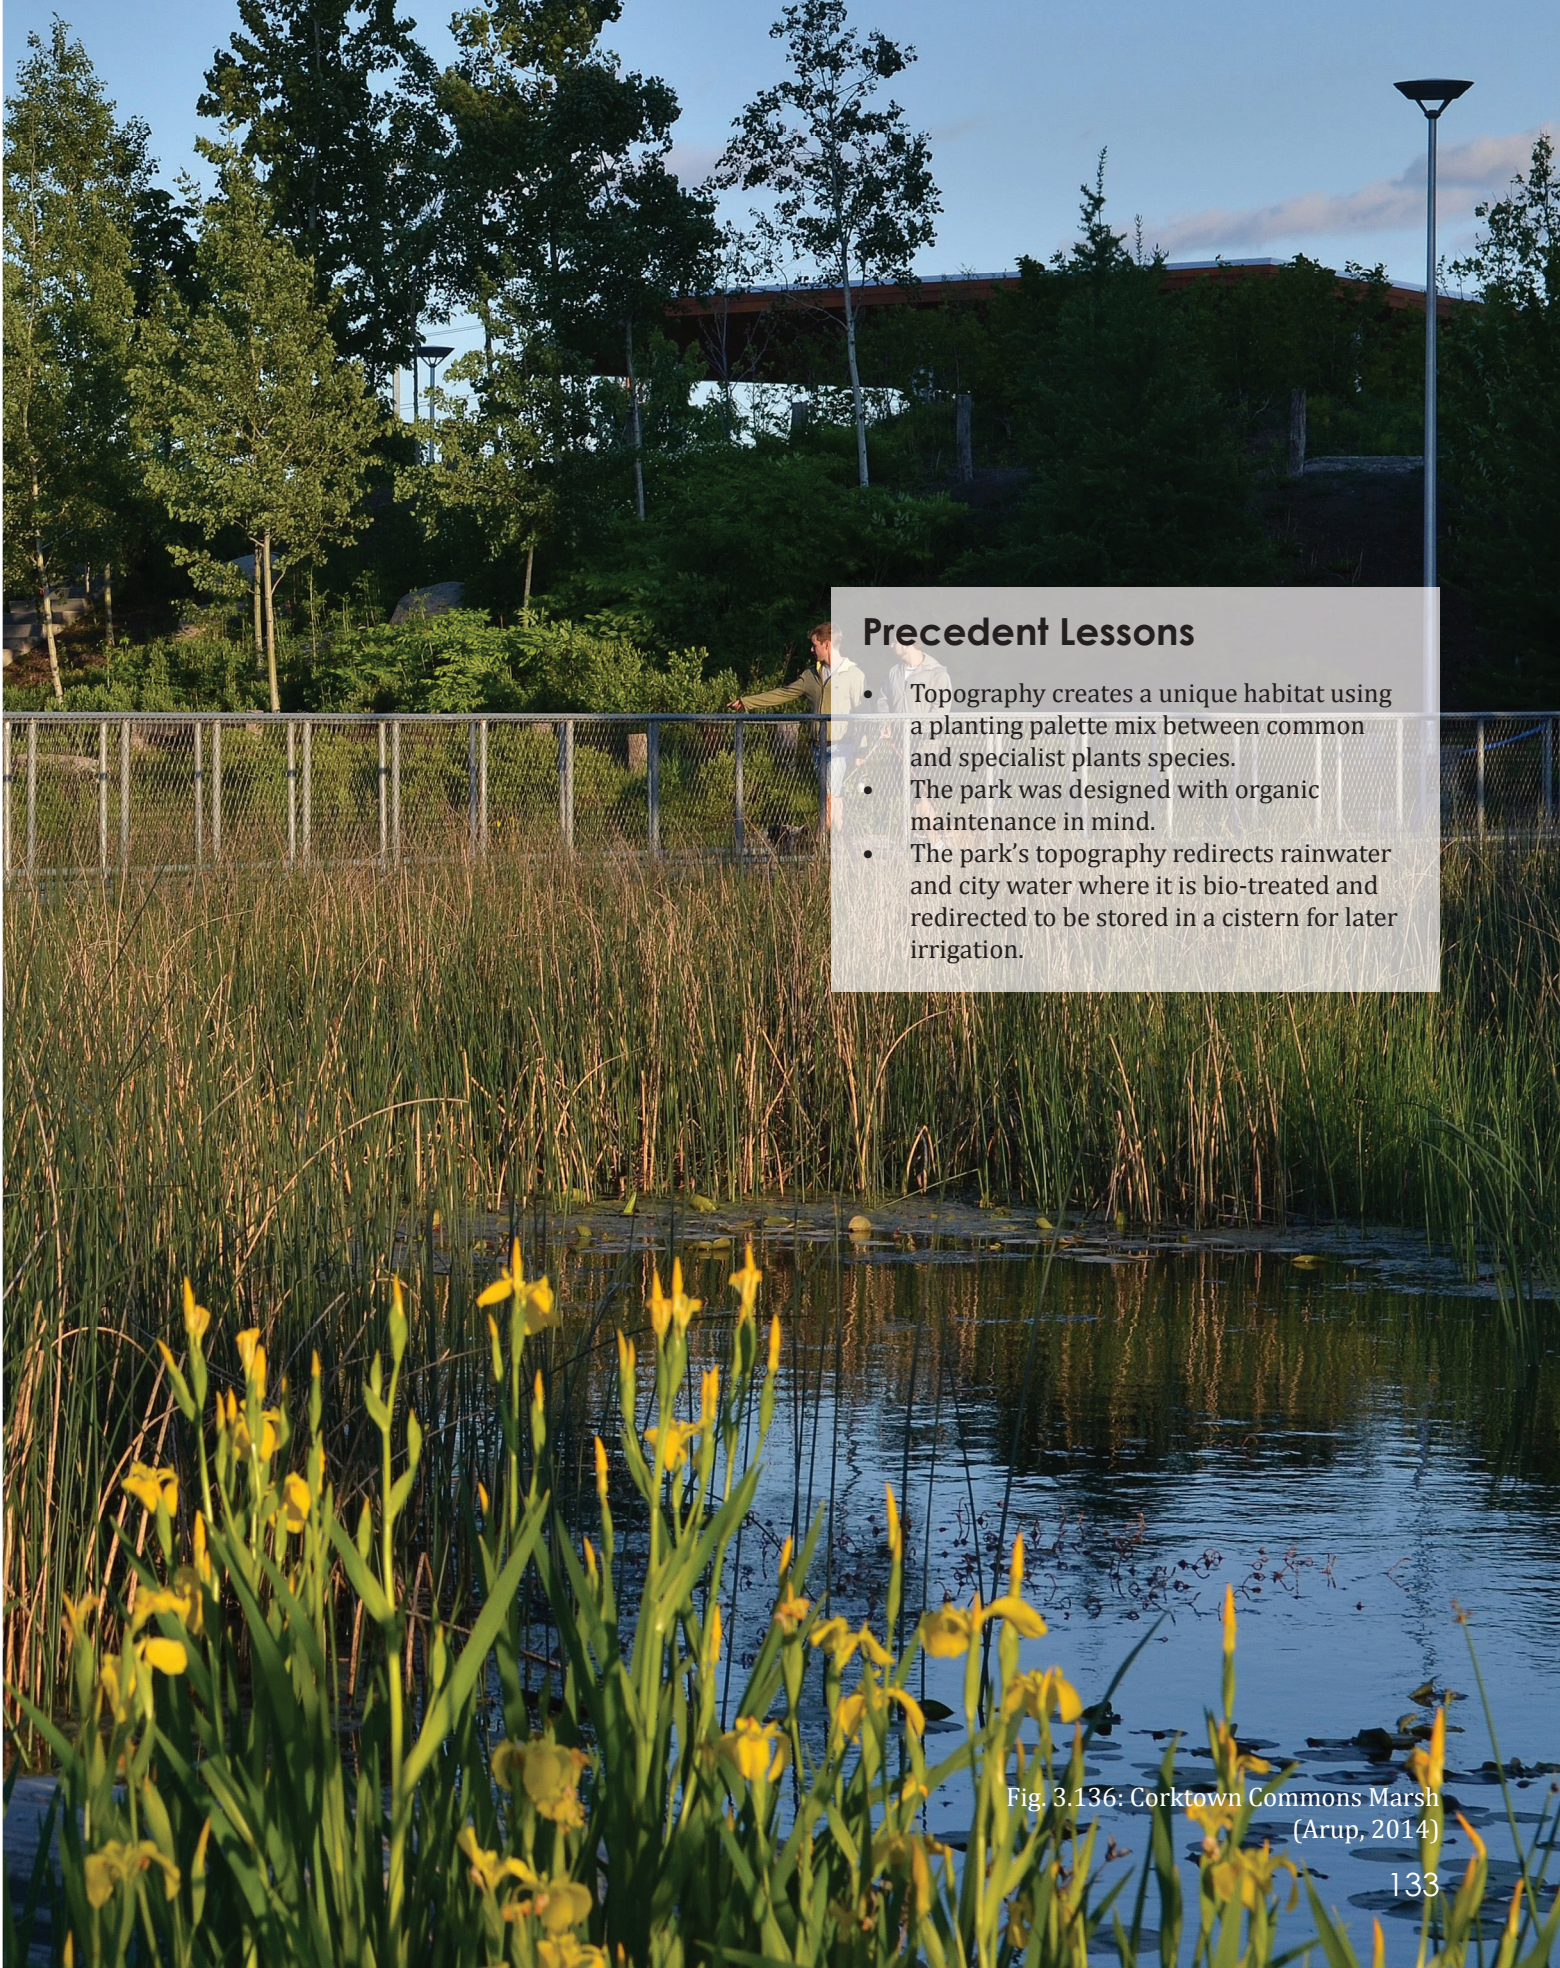
A hilly park, with pathways and prairie grasses, overlooks the mouth of the Don River, which doubles as a 28 foot-high berm designed to protect the eastern downtown from a major flood. On the river side of the park, there is an additional 7.9 acre prairie.

The park’s topography redirects rainwater and city water used at the rubberized pad to the marsh, where it is bio-treated and redirected to be stored in a cistern for later irrigation. This movement of grey water into the marsh prevents eutrophication and algal blooms in the summertime (“Michael Van Valkenburgh Associates, Inc.”).

- Topography creates a unique habitat using a planting palette mix between common and specialist plants species.
- The park was designed with organic maintenance in mind.
- The park’s topography redirects rainwater and city water where it is bio-treated and redirected to be stored in a cistern for later irrigation.

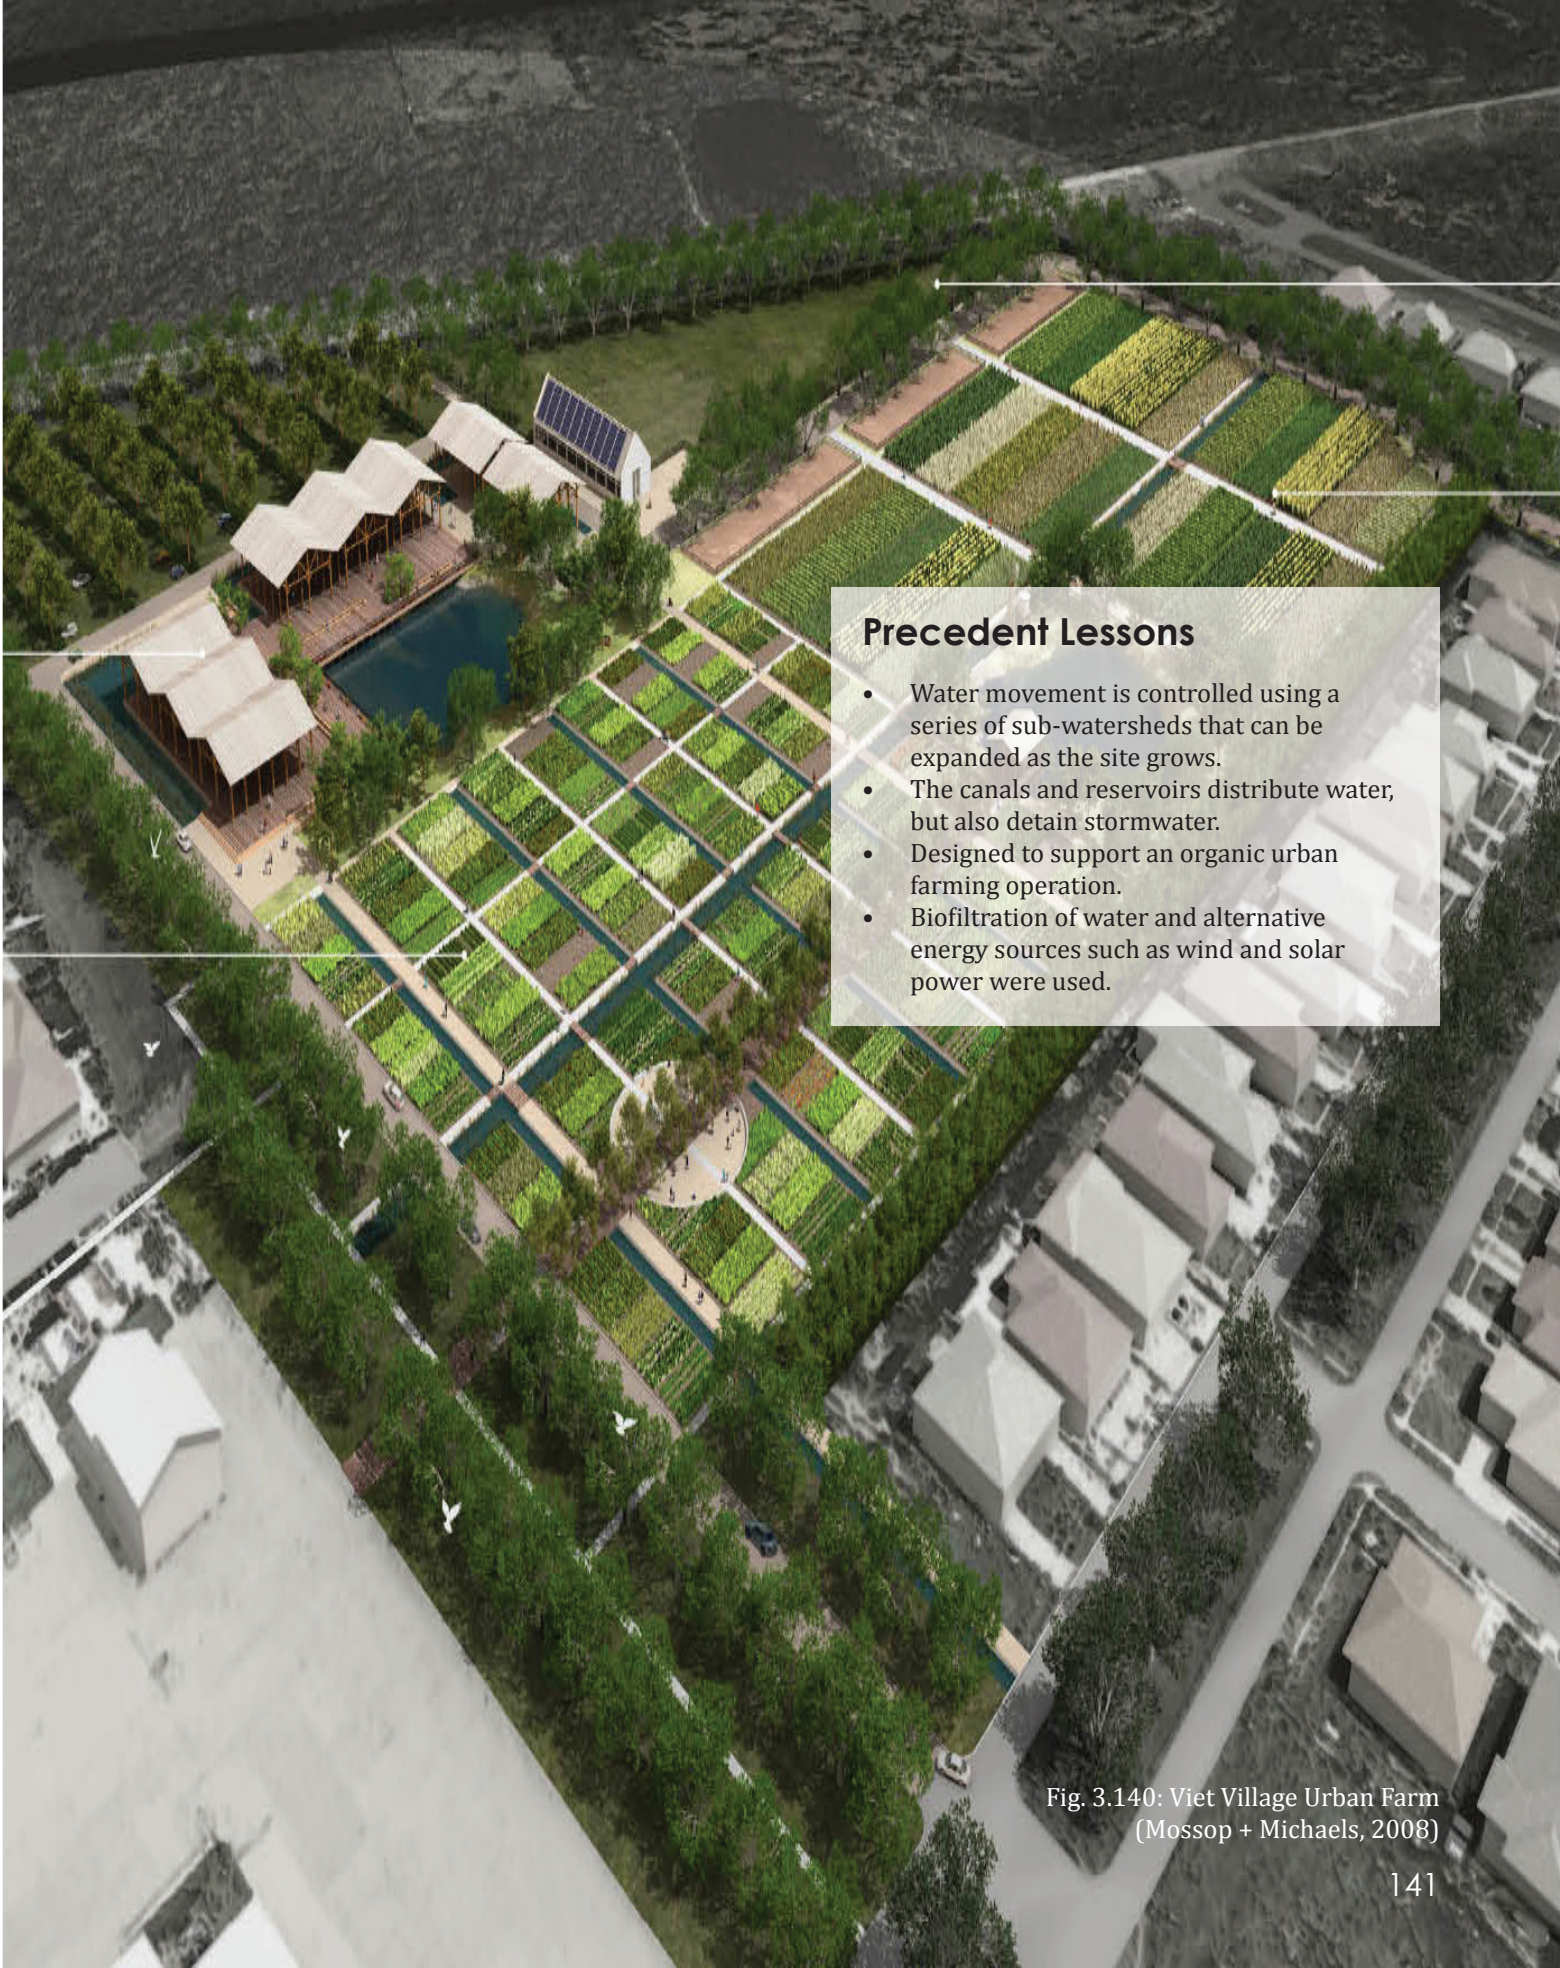
The site’s main canal is designed to hold standing water at depths of 4 to 5 feet year round. The side slopes are planned to grow vegetation, mainly water hyacinth, however the center channel should remain clear. The side canals will be outfitted with a sluice gate in order to isolate each channel if needed. This allows for the channels to be drained and cleaned out. The canals and reservoirs will distribute water to the farm plots, but will also detain stormwater. The proposed design of the site will accommodate a 10 year storm event (“Viet Village Urban Farm”).

- Water movement is controlled using a series of sub-watersheds that can be expanded as the site grows.
- The canals and reservoirs distribute water, but also detain stormwater.
- Designed to support an organic urban farming operation.
- Biofiltration of water and alternative energy sources such as wind and solar power were used.

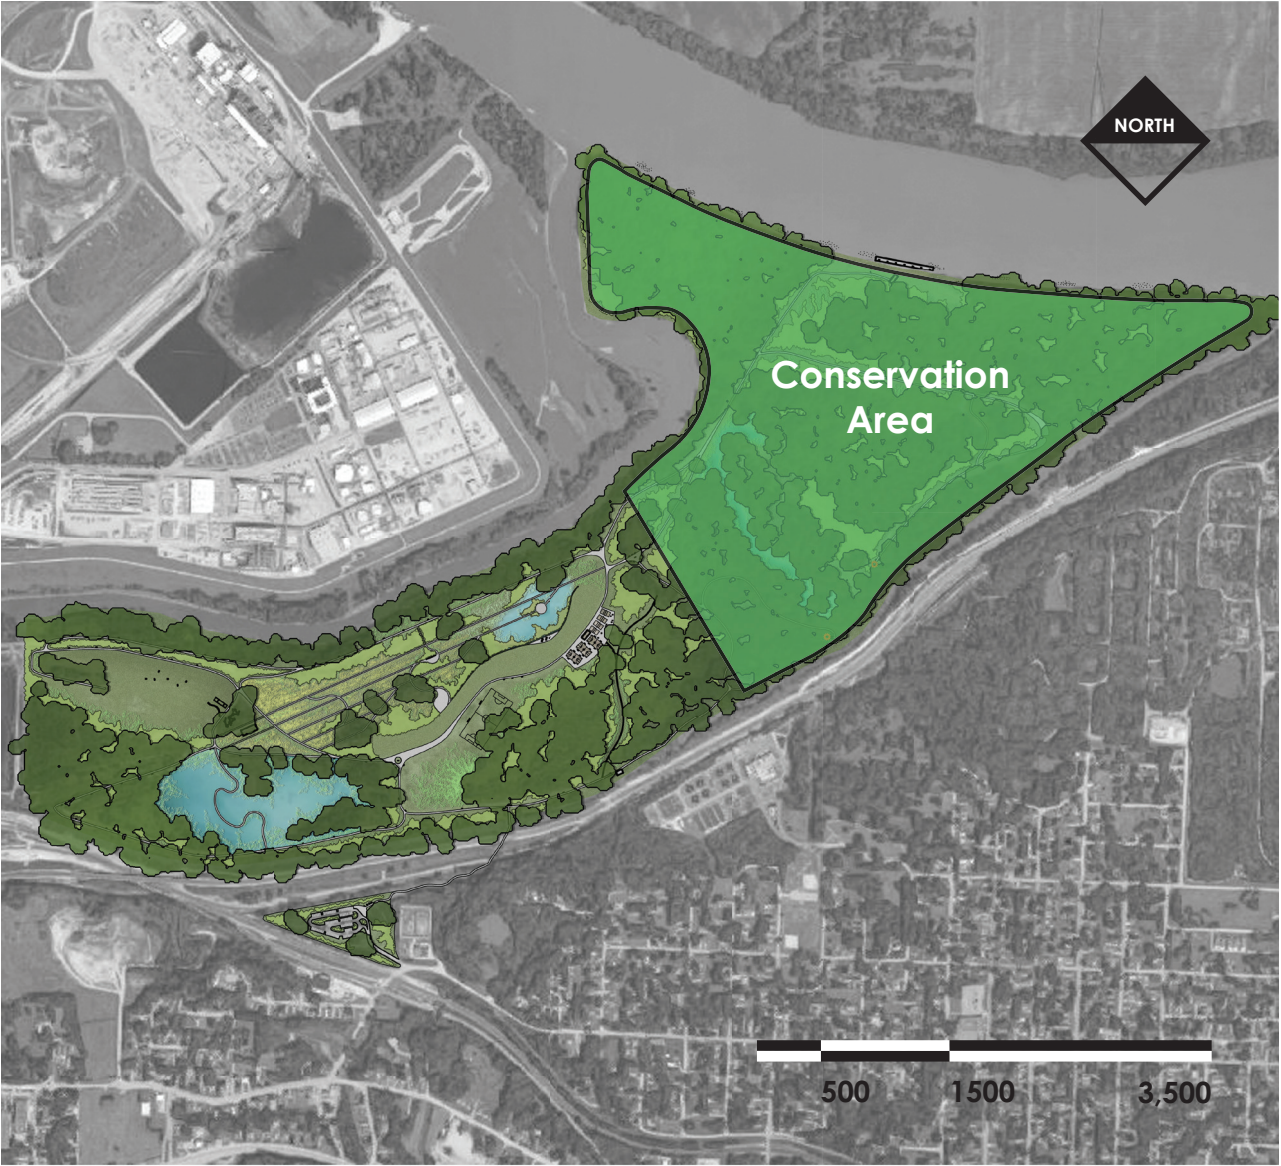
Fig. 4.2: Conservation Area (Swehla, 2017)

of visitors to provide habitat security for the wildlife. A handful of pilings have been placed near the pedestrian viewing platform along the Missouri River to encourage an engaging experience between visitor and wildlife.

This area of the ARMCO Site does have any documented pollution and therefore does not require phytoremediation design.

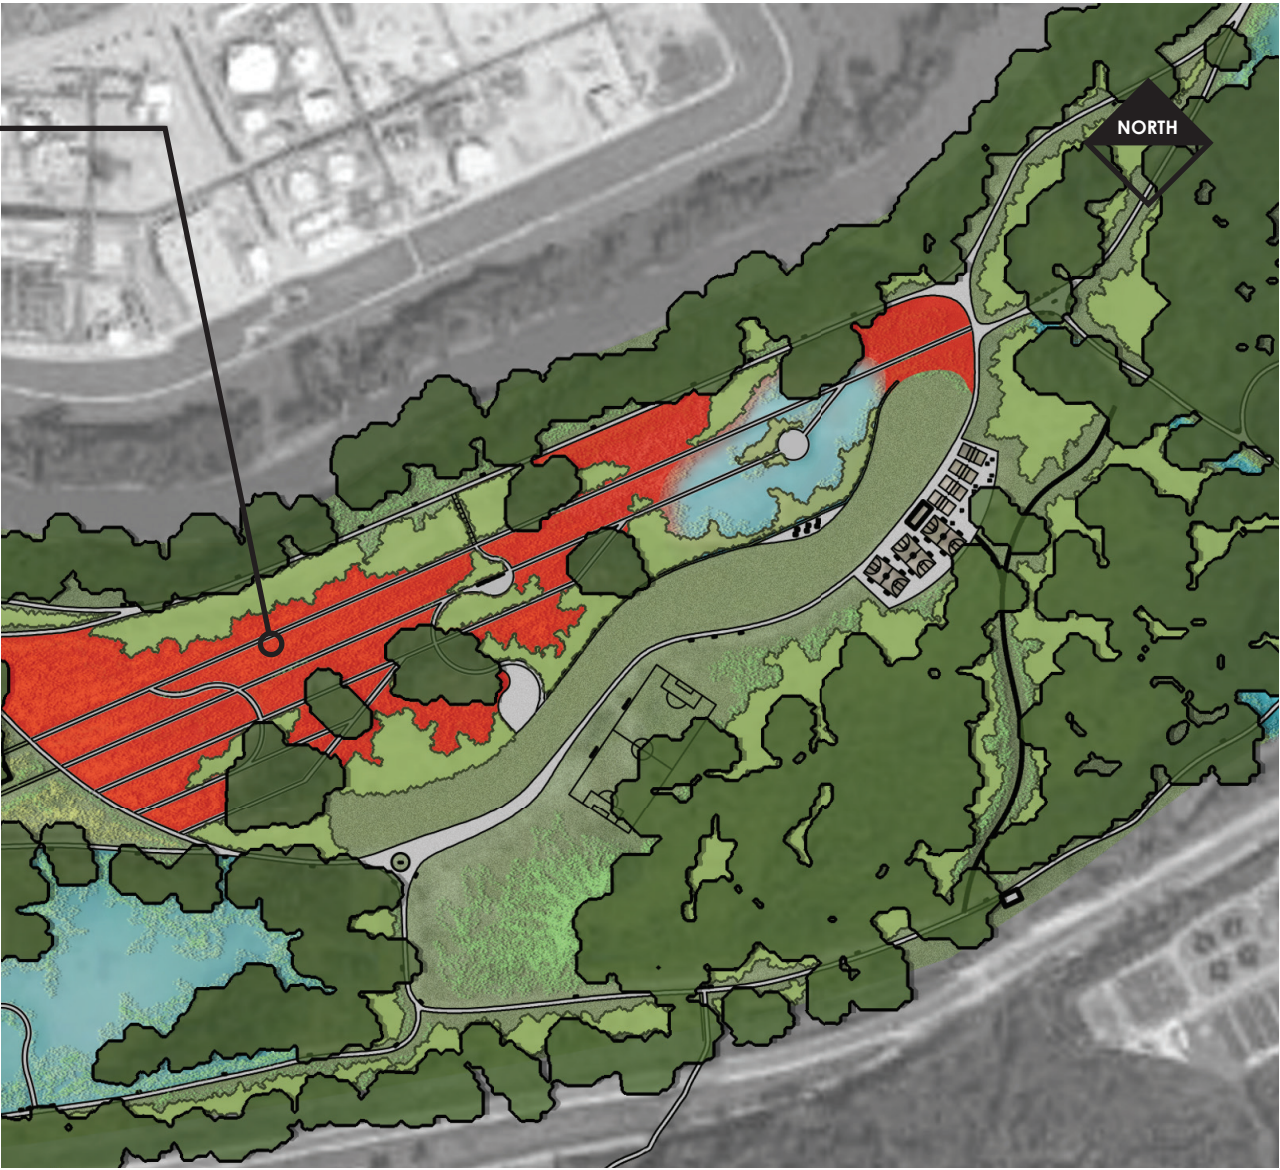
Fig. 4.8: Extraction Plots (Swehla, 2017)

- Phytostabilization
- Phytoextraction

Extraction plots provide habitat for birds, insects, and ground mammals such as deer, squirrels, voles, rabbits, mice, and fox. The extraction plots require frequent harvesting to remove the chemical pollutants being stored in the biomass. An insufficient

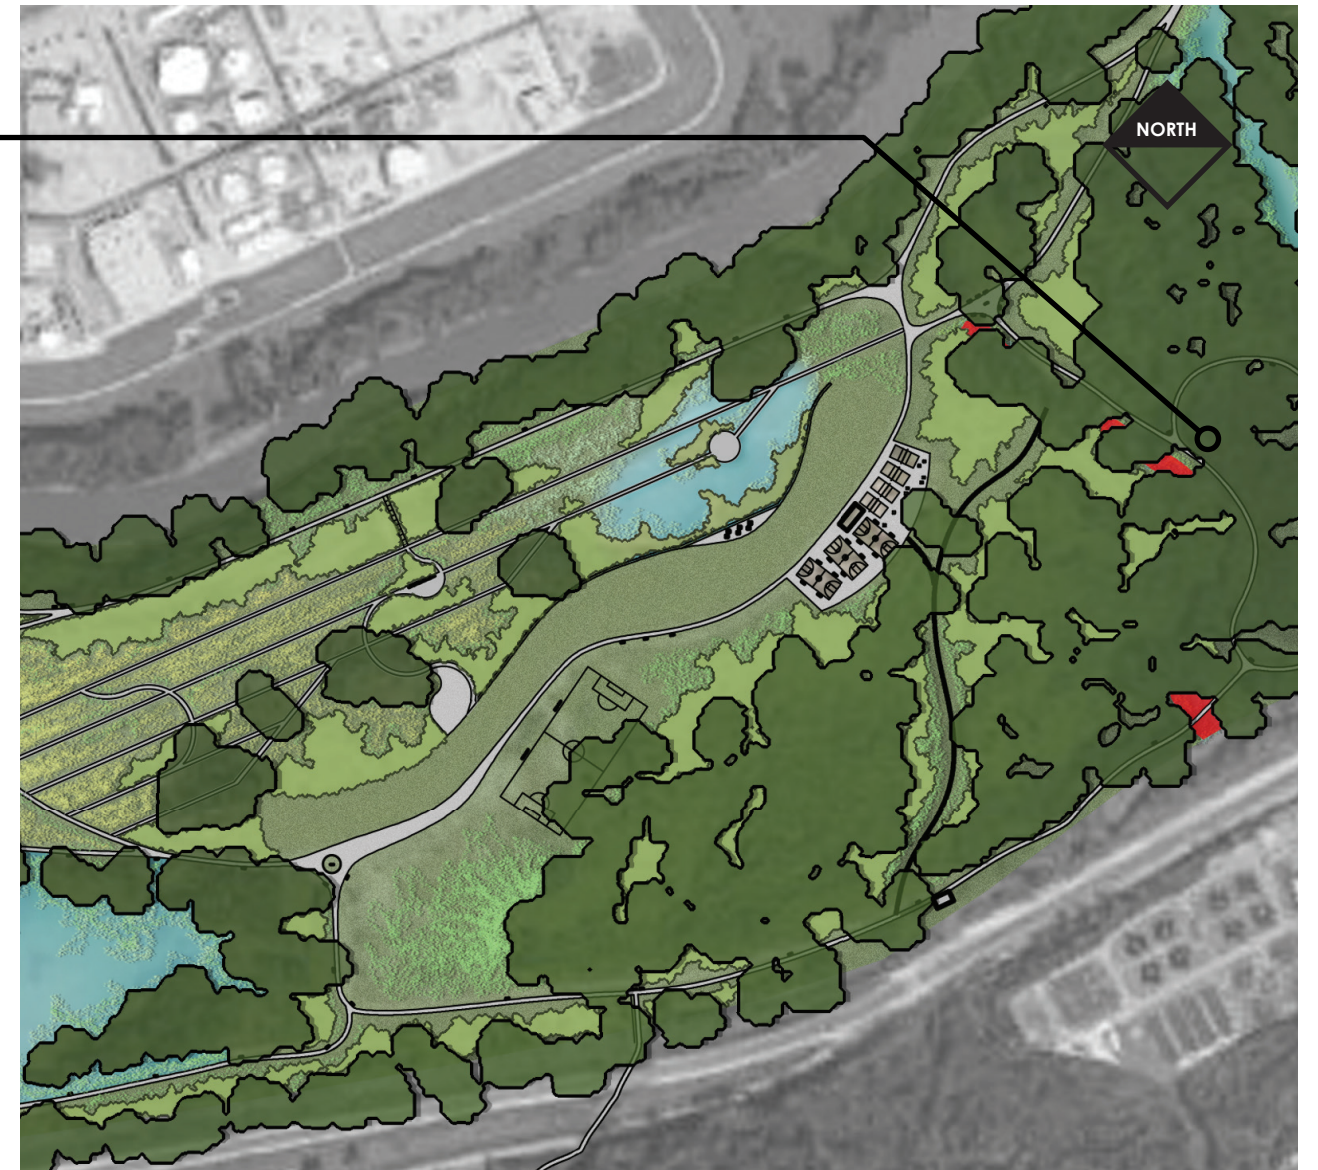
Fig. 4.20: Stormwater Filter  
(Swehla, 2017)

pollutants in stormwater. To control the movement of stormwater through the treatment field, two phytohydraulic planting types were used along the edges to trap water (interception hedgerows and groundwater migration tree stands). These planting types also control stormwater from infiltrating into the East landfill. The constructed wetland is designed to hold a water volume equal to a 10 year/24 hour storm typical of the Kansas City region. At capacity, the wetland will discharge overflow into a stormwater filter built inside the Rock Creek box for further treatment.

Stormwater is collected along the East edge of the treatment field where chemicals are broken down through rhizofiltration in the constructed wetland. At capacity, the

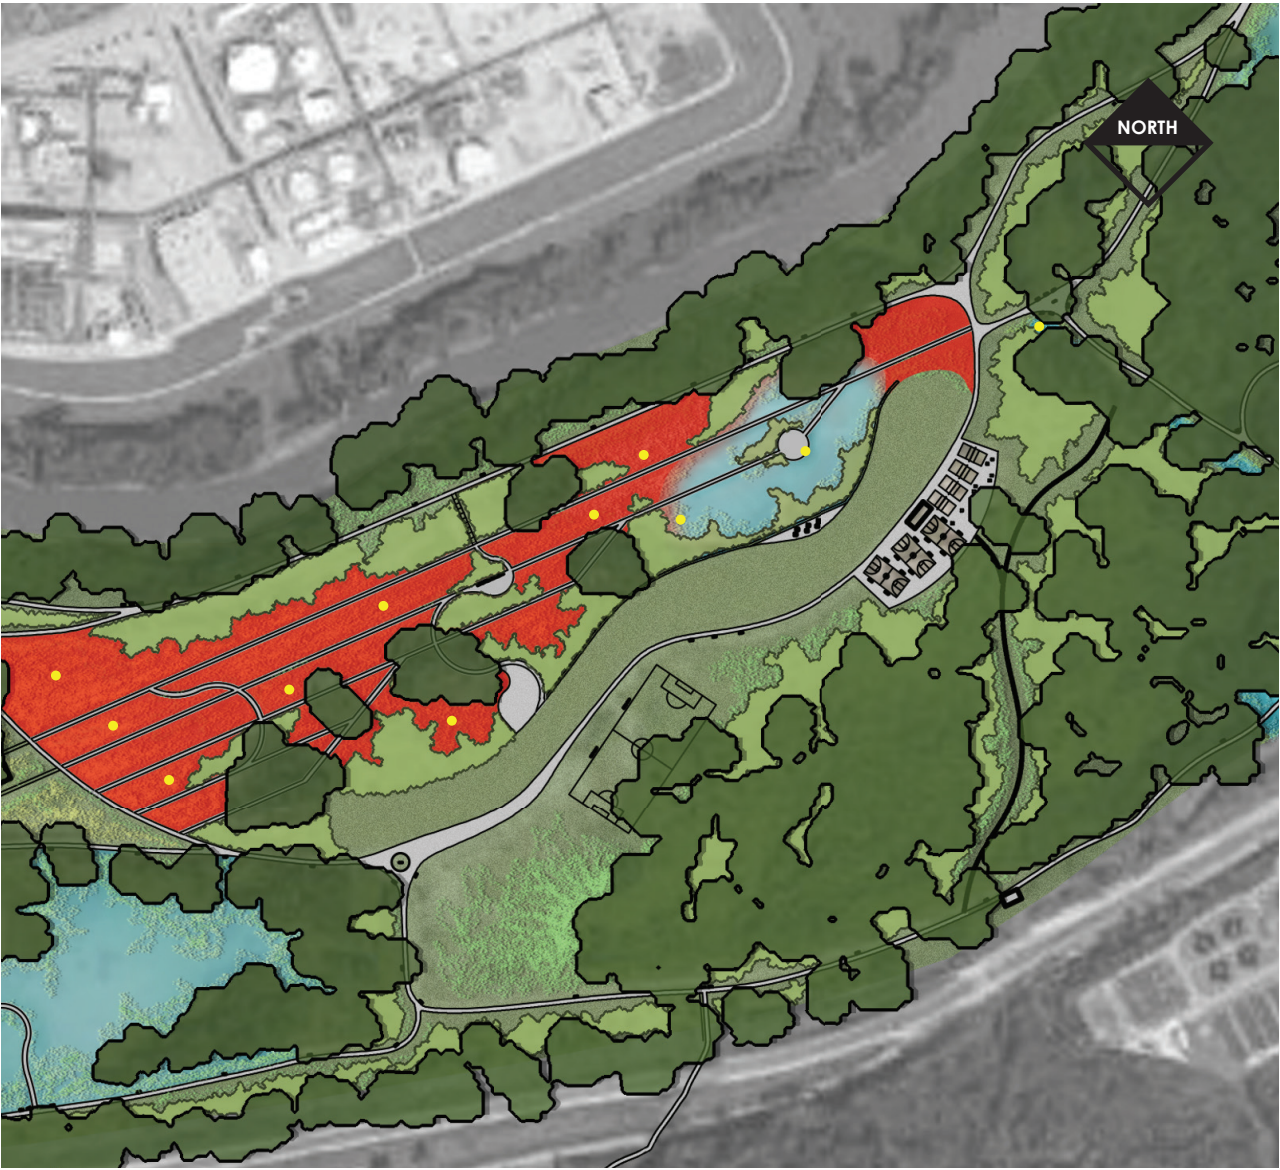
Fig. 4.37: Maintenance and Monitoring (Swehla, 2017)

● = Extraction Plots      ● = Groundwater Monitoring Well

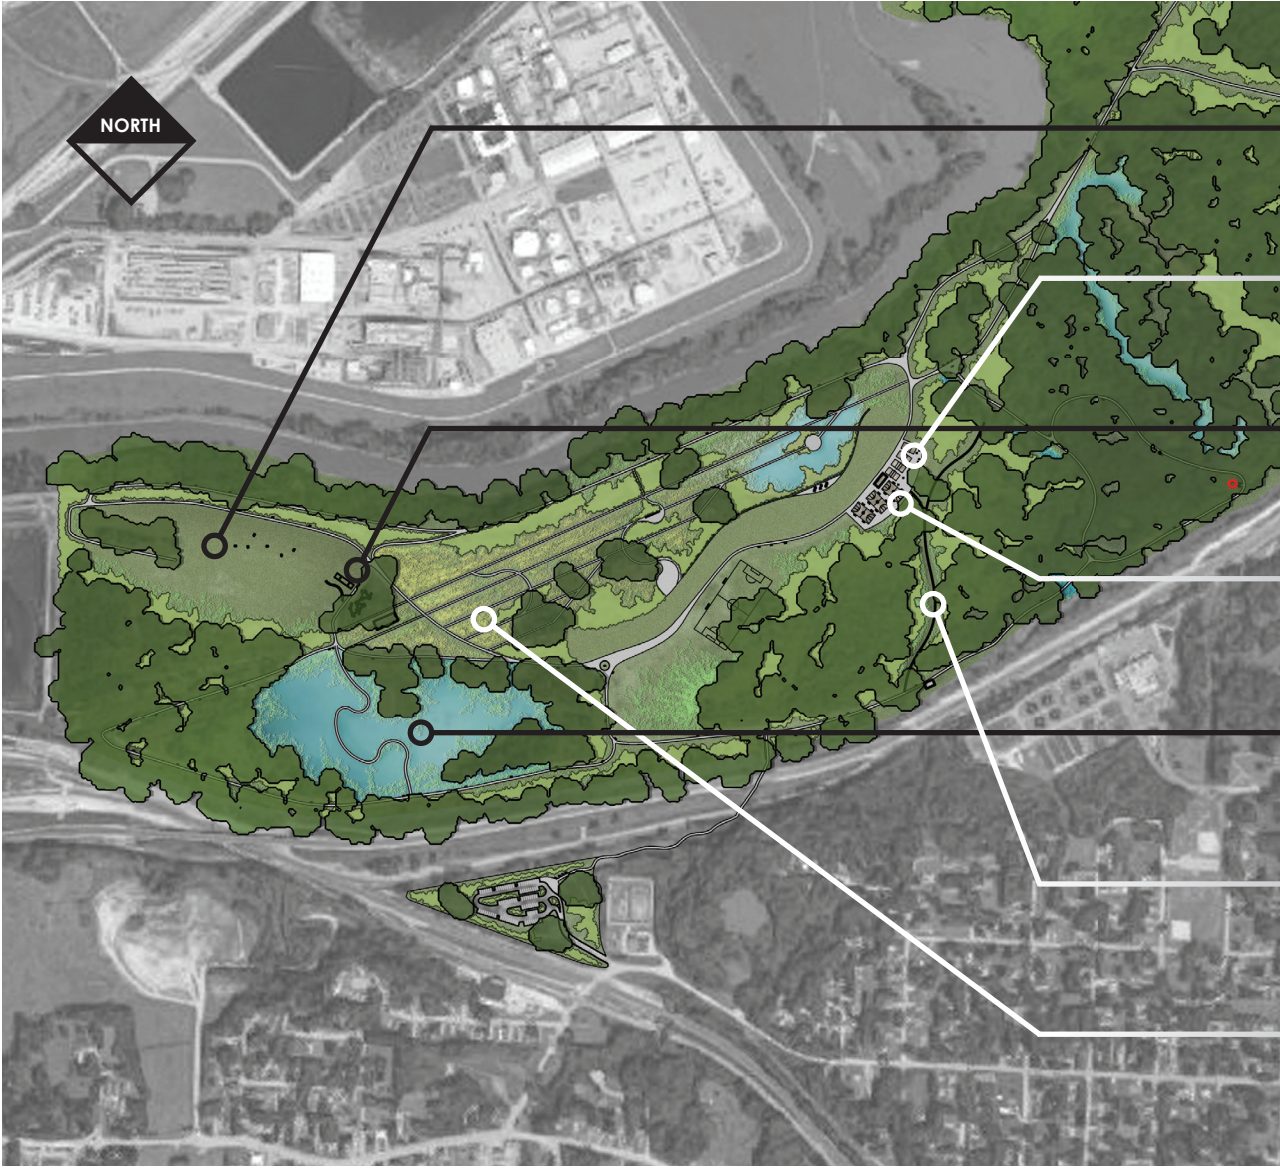
Fig. 4.38: Phytoremediation Area Design Elements  
(Swehla, 2017)

Pilings along the river are intended to build wildlife habitat and create points of visually contact between visitors and the native species within the park. Some of these pilings are placed away from park pathways to create areas of habitat that will undisturbed by human presence.
